NASA Contractor Report 3767

Durability and Damage Tolerance of Large Composite Primary Aircraft Structure (LCPAS)

John E. McCarty and William G. Roeseler

John E. McCarty and William G. Roeseler
Boeing Commercial Airplane Company
Seattle, Washington

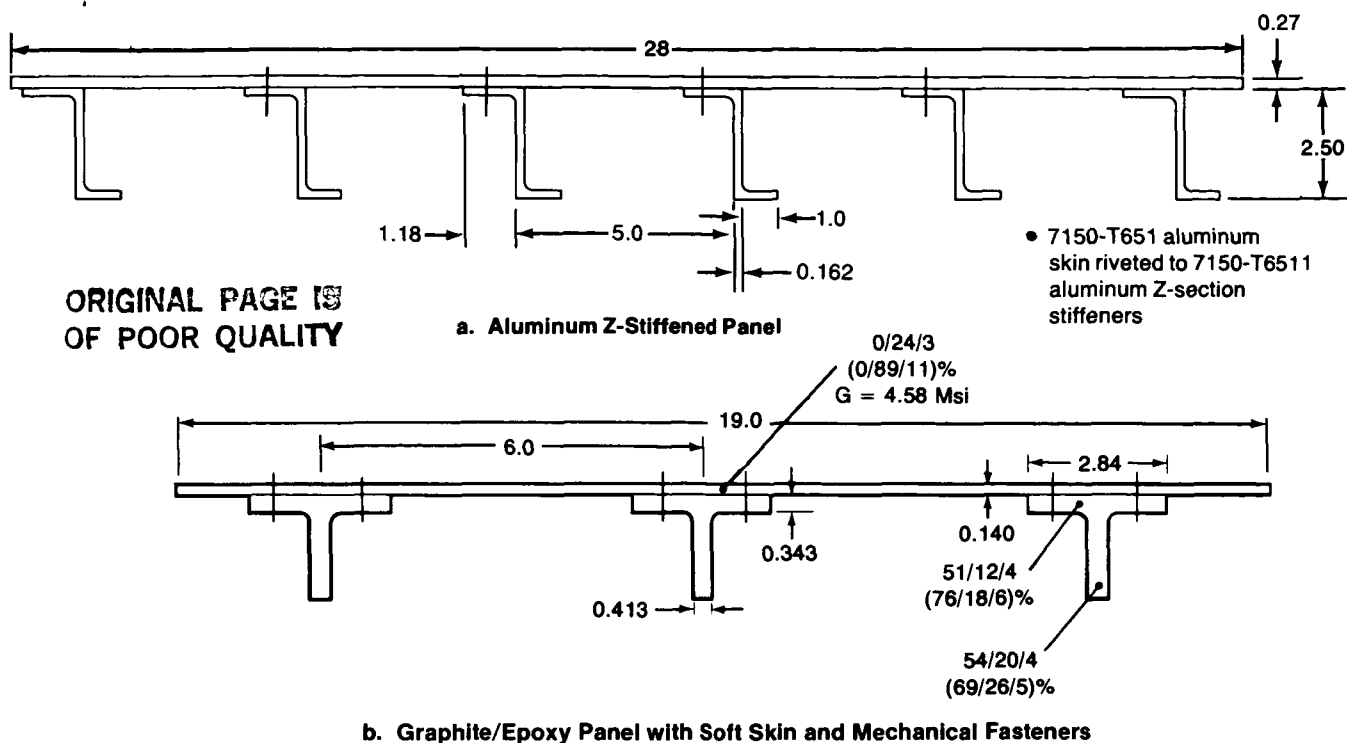
Figure 1. Prior Technology Compression Panels

To focus on the appropriate level of damage tolerance and structural efficiency, the baseline aluminum test panels from the current commercial programs were used. Figure 1a represents the most relevant panel. It has thick skins providing a level of shear stiffness appropriate for the future high-aspect-ratio wing. The skin carries 65% of the total load. In test this panel actually carried 833 kips, 29 kips/in. at 70 ksi ($Gt/Nx = 37$). Aluminum panels are critical for long-column effects (buckling/crippling/Johnson/Euler interaction), and the graphite-epoxy panels are critical for impact damage.

The prior NASA and industry test data on composite compression panels included the damage-tolerant panels of reference 4, which were noteworthy because of the high levels of structural efficiency and damage tolerance demonstrated in test. These panels were designed to meet end load and stiffness requirements of current commercial transport aircraft and to provide damage tolerance with respect to external skin damage. The strongest panel, illustrated in figure 1b, carried 509 kips, 28 kips/in. at 59 ksi ($Gt/Nx = 23$) after impact. This panel had several damage-tolerant features, including soft skins, closely spaced stiffeners, and mechanical fasteners. Although the 0.14-in.-thick skins, laid up (0/89/11)%, had enough shear stiffness ($Gt = 640$ kips/in.) for most areas of current aircraft, the LCPAS study section required almost twice as much shear stiffness ($Gt = 1200$ kips/in.).

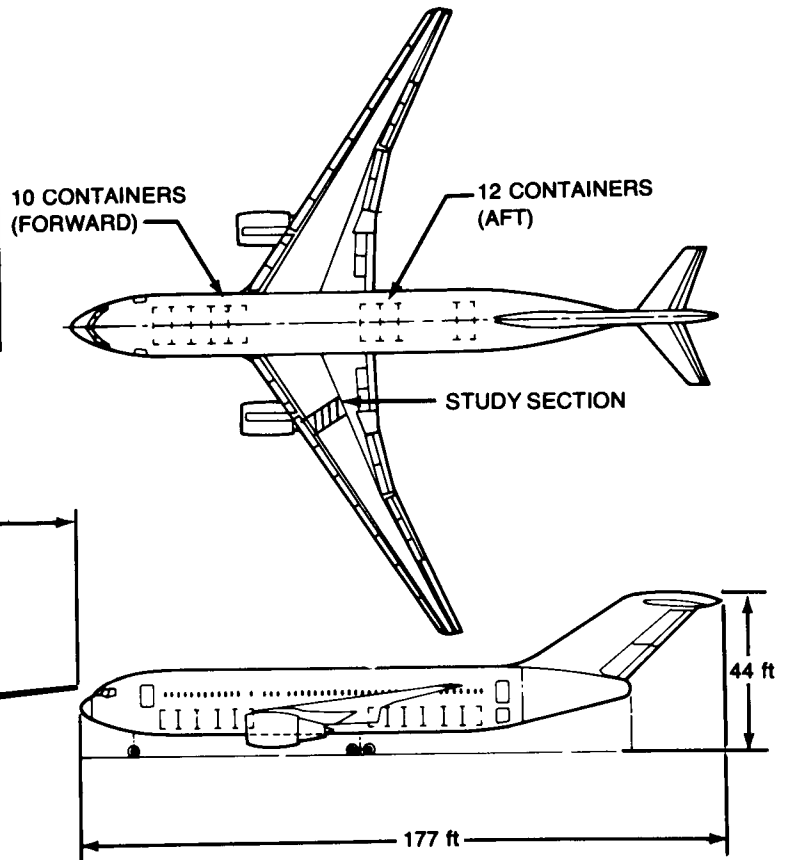
Figure 2. Reference Airplane

The airplane shown in figure 2 is a fuel-efficient, 200-passenger airplane with a high-aspect-ratio wing. Internal loads and stiffness requirements for the wing, developed in the previous NASA contracts (ref. 2), are shown in figure 3. The area of the wing selected for study on this program was the upper wing panel at the nacelle, where end loads approach 30 kips/in. and the shear stiffness requirement is $Gt = 1200$ kips/in. ($Gt/Nx = 40$).

PASSENGERS MIXED CLASS ALL TOURIST	197 207
ENGINES	TWO CF6-6D2
WEIGHTS (lb) TOGW OEW	268 040 176 120
ASPECT RATIO	12.0

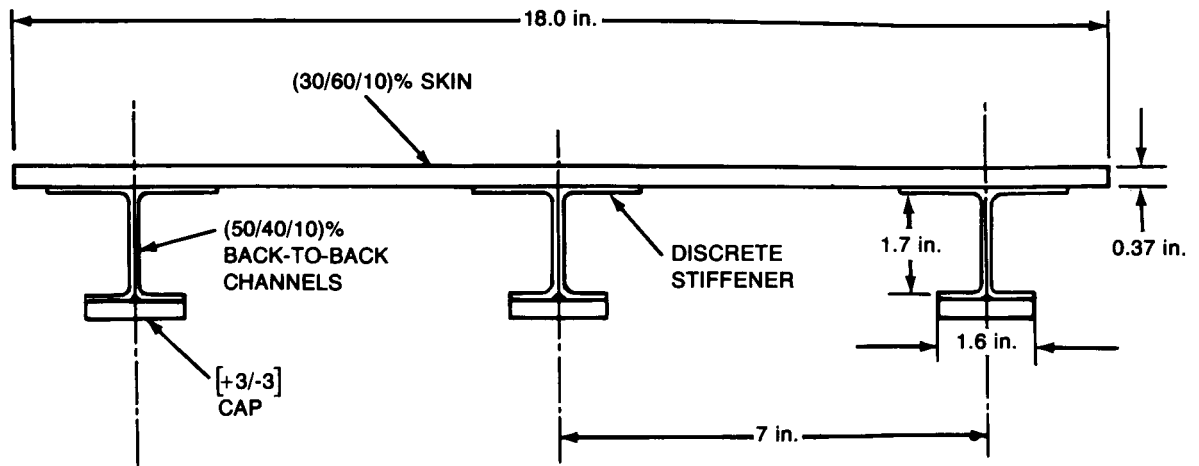
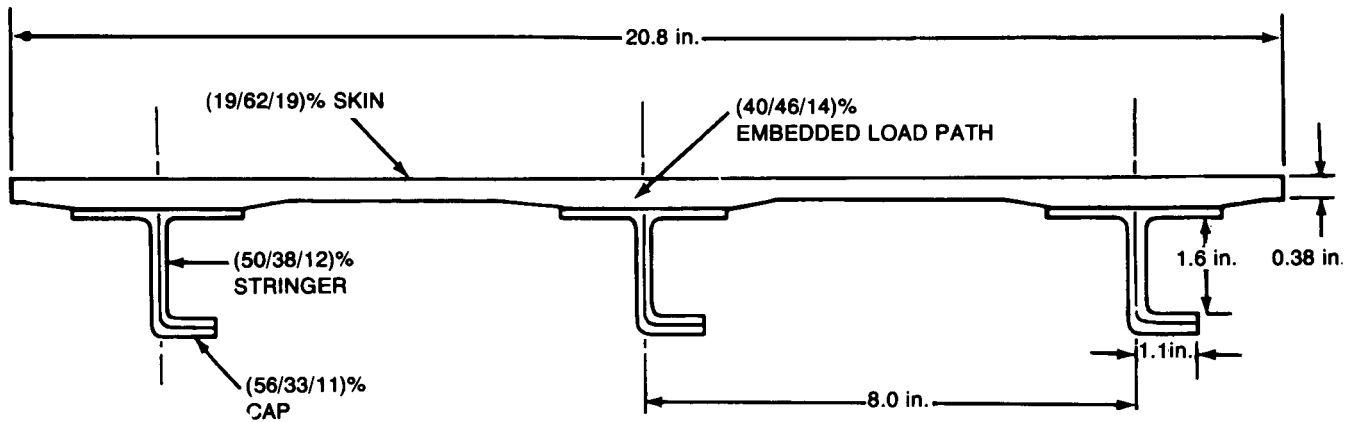
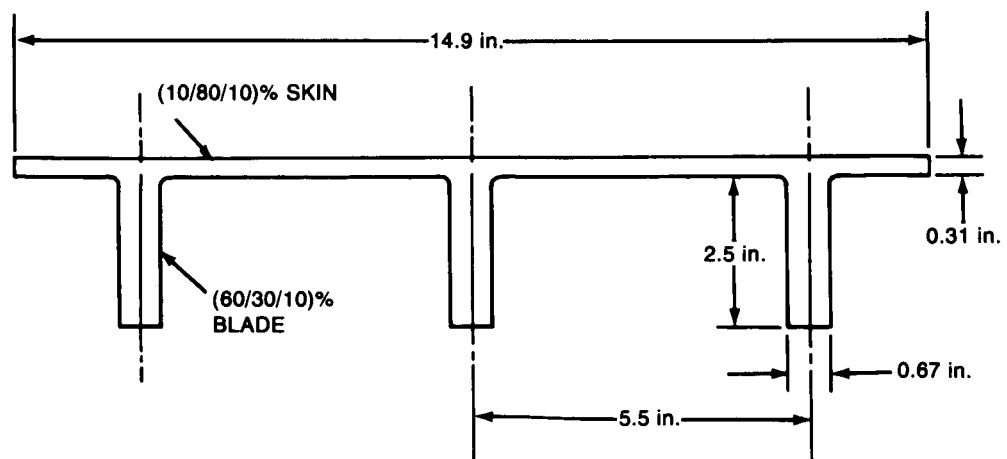
Figure 4. Selected Structural Concepts

The I-stiffened concept represents the most optimistic of the three, having a substantial percentage of 0-deg material in all three elements and a target ultimate stress of 58 ksi. The damage-tolerance features of the I-stiffened panel include: (1) stable stiffeners with excess Euler buckling capability to better carry load around damaged areas; (2) discrete stiffeners capable of being mechanically attached to the skins in case of bondline weakness; and (3) uniform channels permitting good compaction of plies in the radii and facilitating automated manufacture. The target mass reduction for the I-stiffened panel was 33% compared with the 70-ksi aluminum test panel.

The J-stiffened concept was assessed to have minimum risk of failing the damage-tolerance tests. Damage-tolerance features include: (1) embedded 0-deg material protected from impact damage by 45-deg plies on all sides; (2) wide attachment flanges on the stringers to increase the bond area between the skin and the stringers and to allow for mechanical attachment with 5/16-in.-diameter fasteners; and (3) gradual transition from (19/62/19)% skin to (56/33/11)% cap to provide minimum Poisson ratio mismatch between adjacent elements. The target stress level for the J-stiffened concept was 52 ksi, providing a 25% mass reduction.

The blade-stiffened concept was estimated to be the lowest cost of the three and provided a mass reduction potential equal to that of the low-risk J concept. Damage-tolerance features of the blade include: (1) soft (10/80/10)% skin, which is believed to have better load redistribution capability (toughness) than the (30/60/10)% skin of the I-stiffened panel or the (19/62/19)% skin of the J-stiffened panel; (2) closely spaced stringers, providing a nearby load path for redistribution of load around damaged areas; and (3) interleaving of the 0-deg and 45-deg material at the base of the blade, providing a redistribution load path between the skin and the stringer that does not rely entirely upon bondline strength.

Considering the strength, stiffness, and damage-tolerance requirements, a series of preliminary designs was completed for the upper and lower wing panels. The design studies considered various damage-tolerance features such as discrete stiffeners, mechanical fasteners, soft skins, wraps of soft material around the 0-deg-dominated areas, and closely spaced stiffeners. Graphite-epoxy experience indicates that more technology development is required for damage tolerance of the upper panel. The detailed designs and the test program were therefore oriented toward the upper surface panels. The three upper panel designs shown in figure 4 were selected for fabrication and test and represent three distinctly different concepts. All were designed to carry 30 kips/in. of compression load at 0.006 strain while providing a shear stiffness of 1200 kips/in. ($Gt/Nx = 40$).

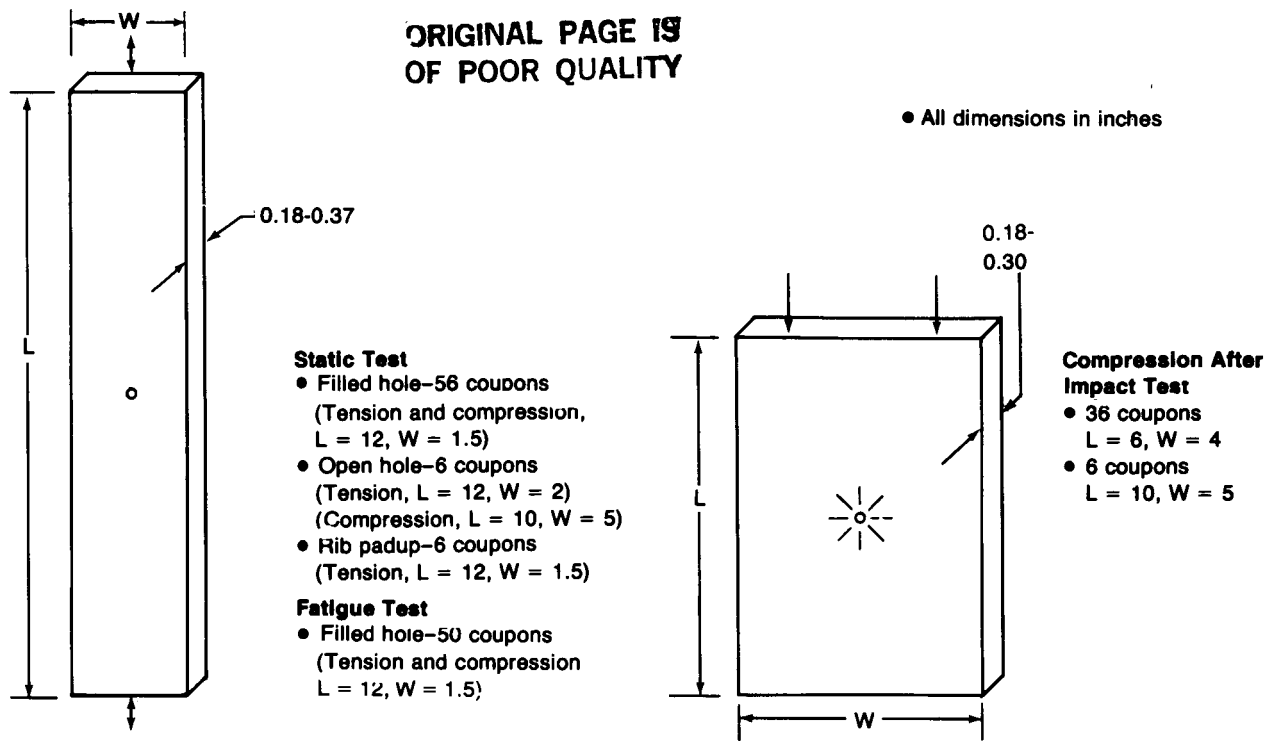
Figure 5. Coupon Program

Following the preliminary design studies, a coupon test program (fig. 5) was formulated to address the range of laminates appearing in the upper and lower wing panel concepts. Static tension, compression, and fatigue tests were conducted at room temperature on 160 coupons cut from 11 different panels ranging from 24 to 50 plies in thickness (0.178 to 0.37 in.). The unloaded fastener was selected as the basic structural detail for the coupon test program. This provided a local stress concentration considered typical of wing structure. In general, countersunk fasteners were used for the candidate skin layups and protruding-head fasteners were used for the stringer layups. Coupons were tested to compare the current-technology material system (T300/5208) with the selected, toughened system (AS4/X2220-3) used for most of the LCPAS tests. Open-hole coupons and impact coupons per reference 6 also were tested to characterize the AS4/X2220-3 material system relative to other toughened systems selected by the other LCPAS contractors. Layups ranged from the soft, all-45-deg laminate to the stiff $[+3/-3]$ -deg laminate.

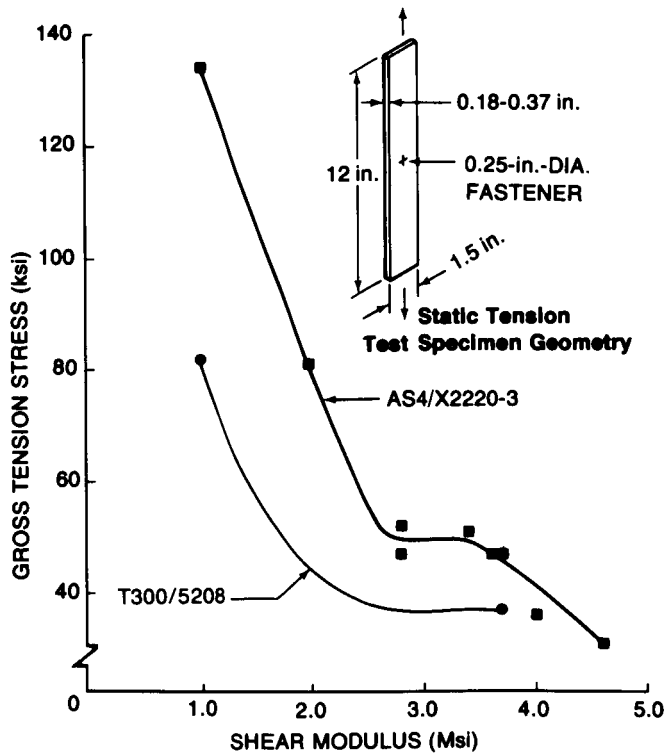
Figure 6. Tension Strength Data

Figure 6 summarizes the static tension data from 39 coupons with fastener-filled holes. Test results are tabulated in table 1. For the two layups providing material evaluation data, the AS4/X2220-3 material was 32% to 73% stronger than the T300/5208 material. Of the candidate stringer layups, the $[+3/-3]$ -deg laminate was 65% stronger than the (60/30/10)% laminate. Of the candidate skin layups, in terms of failure strain, the all-45-deg laminate was much better than the (8/84/8)% laminate, and the (8/84/8)% laminate was much better than the isotropic laminate. These large differences in stringer load capability and skin strain to failure provide some guidance for design of damage-tolerant structure. Fiber orientation and material characteristics together can provide strong load paths to carry load around damaged areas, and high strain skins may be effective in redistributing load from the damage site to the adjacent structure.

In general, the coupon tension results support the target design allowables for tension panels. The rib padup tests indicated that a 10% improvement in static tension strength is available with a 20% unsymmetrical padup. Depending on the knockdown factors to be assigned for statistical variation and environmental effects, some local padups may be required on the tension material.

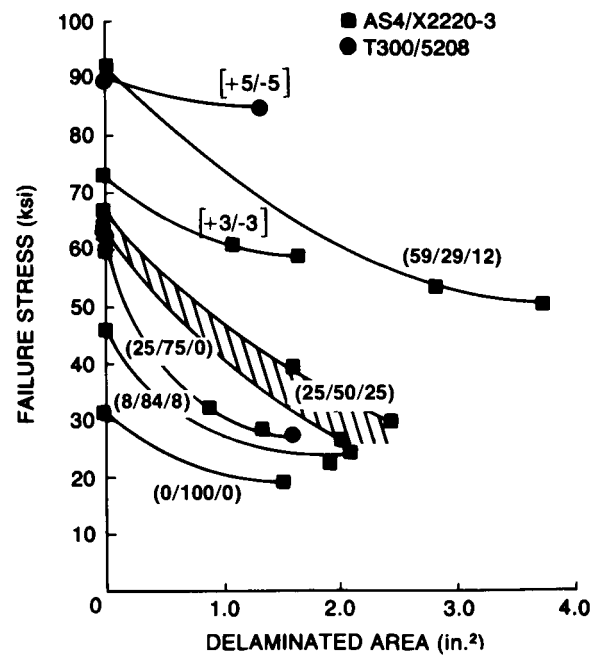
Figure 7. Compression Strength Data

Figure 7 and table 2 summarize the significant compression coupon results. For the AS4/2220-3 material system, the compression strength after 140 in.-lb impact was 18% better than that of T300/5208. Filled-hole compression results are included in table 2 and figure 7. The results show that the filled-hole compression strength is less critical than compression-after-impact strength.

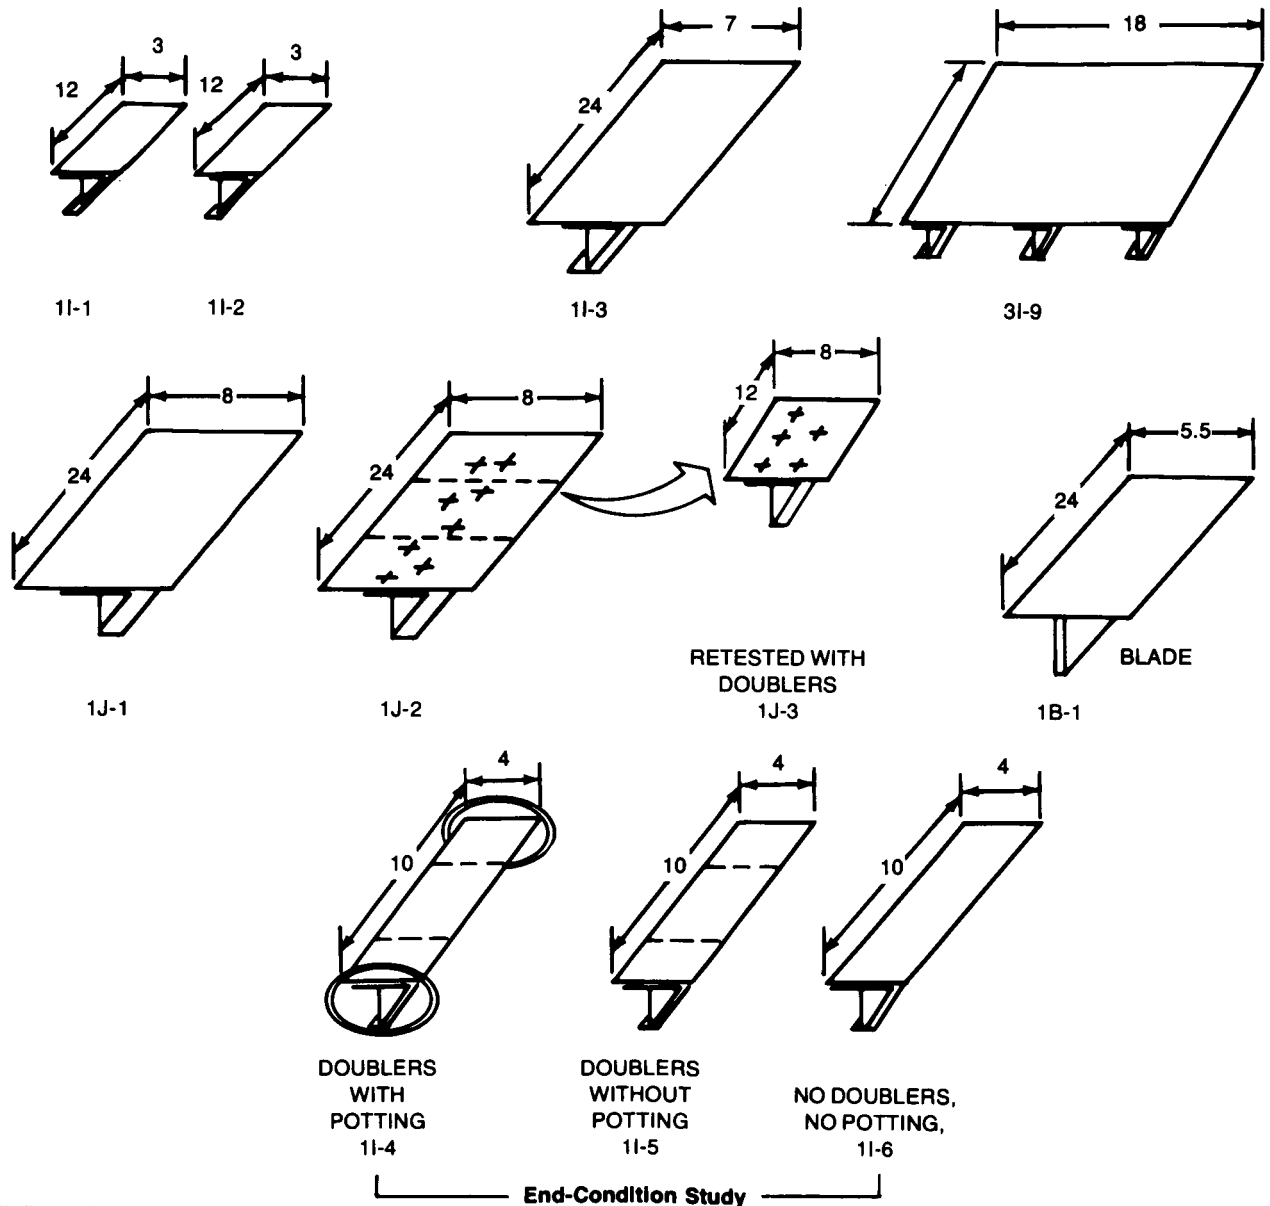
Figure 8. Undamaged Structural Elements and Panels

Each of the selected upper panel concepts was tested first as a one-stringer element in the undamaged condition, as shown in figure 8. Before testing the formal designs with full skin bays, two developmental stringers (1I-1 and 1I-2) were tested with only 3 in. of skin. All three concepts were later tested with full skin bays to obtain undamaged baseline data (1I-3, 1J-1, and 1B-1). The J-stiffened concept was tested with and without a double row of 0.25-in. bolts through the skin and stringer. All the undamaged elements failed near the ends. The J-stiffened concept was retested after reinforcement of the ends (1J-3), and the load improvement was 6%. Further tests of undamaged I-stiffened structural elements (1I-4, 1I-5, and 1I-6) and panel (3I-9) showed that load improvements up to 12% are possible with ends reinforced by hot-bonded doublers.

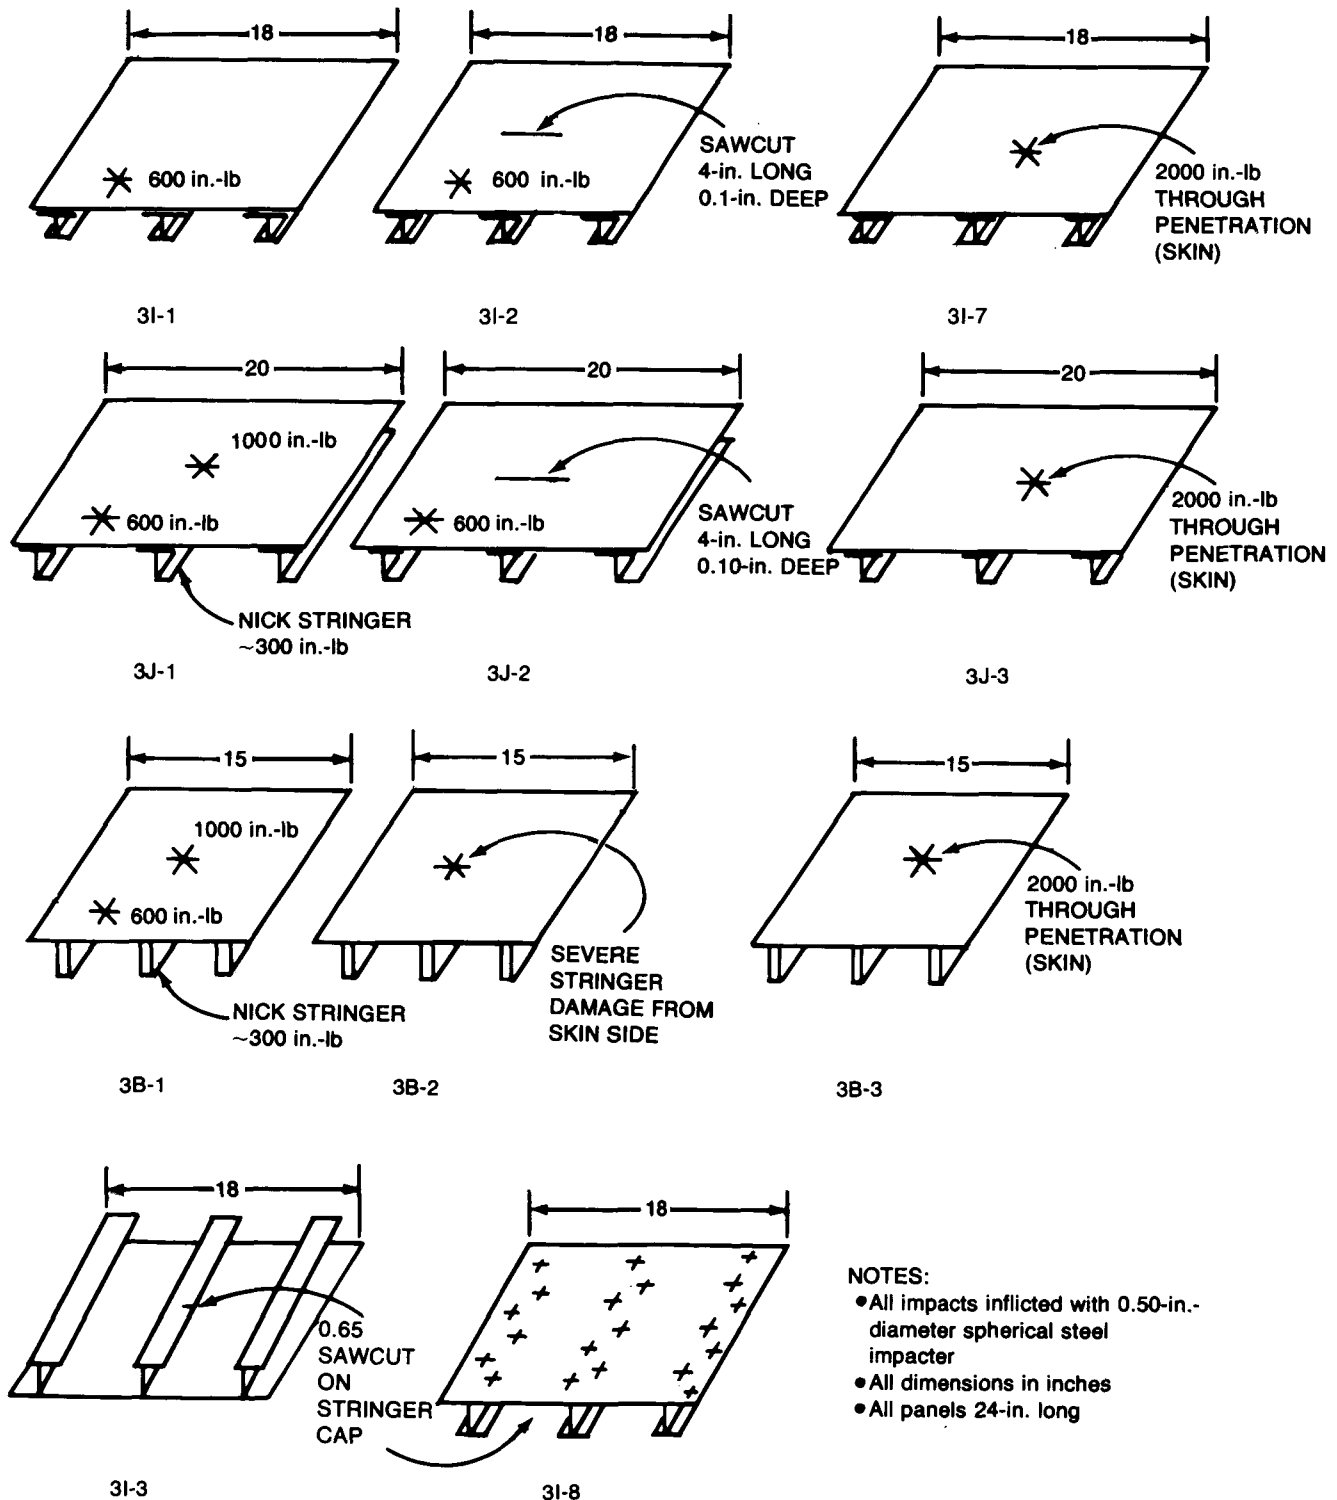
Figure 9. Damaged Compression Panels

The test plan for the three-stringer panels was designed to provide data on various levels of damage up to the limits allowed by the size of the panels and to correlate coupon and panel results for establishment of realistic wing design guidelines (fig. 9). Panel 3I-1 was tested to failure after nonvisible impact damage to the skin between stringers to correlate the compression-after-impact coupon results with wing structure results. Panel 3I-3 was tested to failure after nearly half of the [+3/-3]-deg stringer cap was severed. This test was essential to establish the damage tolerance of the discrete, bonded stringers with respect to severe stringer damage, even though this type of damage is considered unlikely in service.

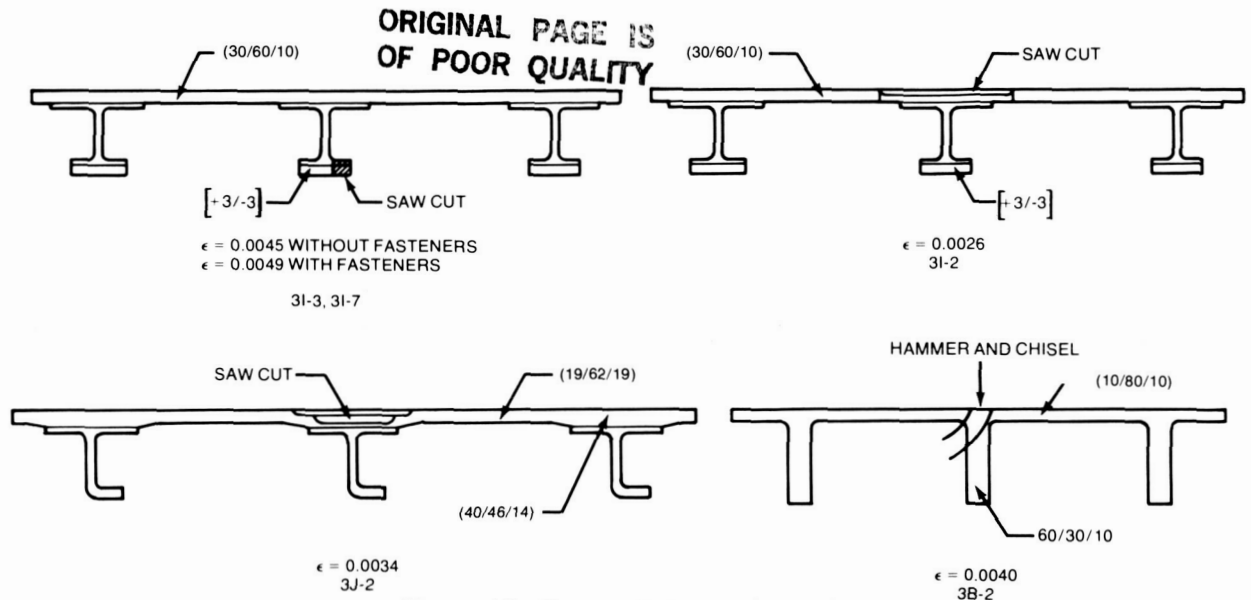
Figure 10. Severe Cuts and Impacts

Figure 10 shows the maximum damage levels sustained by LCPAS panels. The severe stringer damage was described above. The skin cuts on panels 3I-2 and 3J-2 and the skin side stringer damage on panel 3B-2 represent exploratory levels of damage addressing the FAA requirement for continued safe flight and landing following engine burst. Figures 15 and 16 show all of the LCPAS panel data relative to the final design stresses and strains.

Tests on the remaining panels were oriented toward external damage, because this type of damage is most likely to occur on the wing in service. Panels 3J-1 and 3B-1 were tested to failure after visible impact damage, and panels 3I-7, 3J-3, and 3B-3 were tested after severe impact causing through-penetration. These tests were made to find how the level and location of impact damage affected postimpact strength. Panels 3J-2 and 3B-2 were loaded to a truncated version of a flight-by-flight fatigue spectrum after sustaining nonvisible impact damage and gouges. Damage growth was monitored during approximately six lifetimes of compression fatigue cycles, with limit load cycles and nondestructive inspections after each lifetime. The gouges were increased from 0.1-in. to 0.4-in. depth (fig. 10) prior to residual strength tests. Finally, panel 3I-9 was tested without previous damage to supplement the results of the single-stringer elements tested earlier. Figure 11 shows the panel test setup.

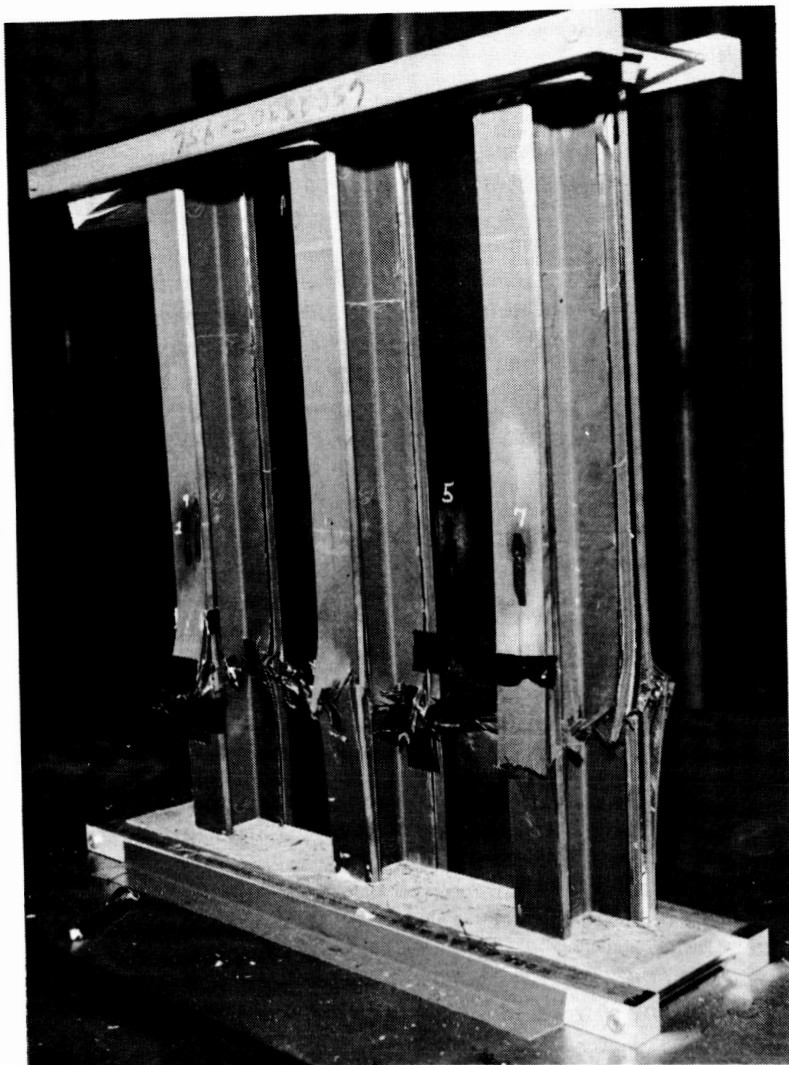
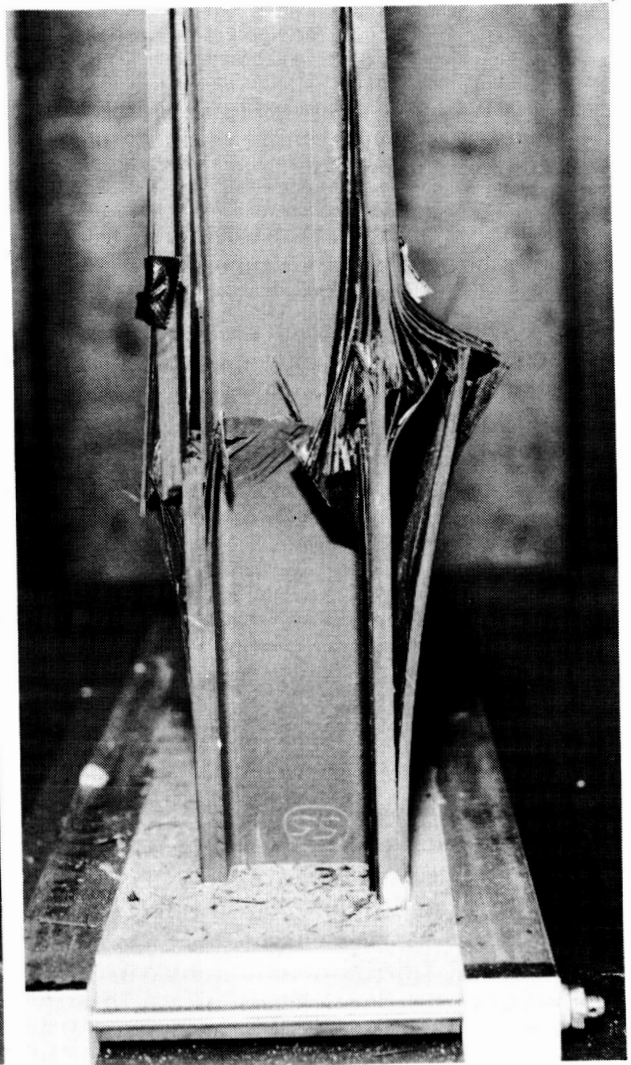
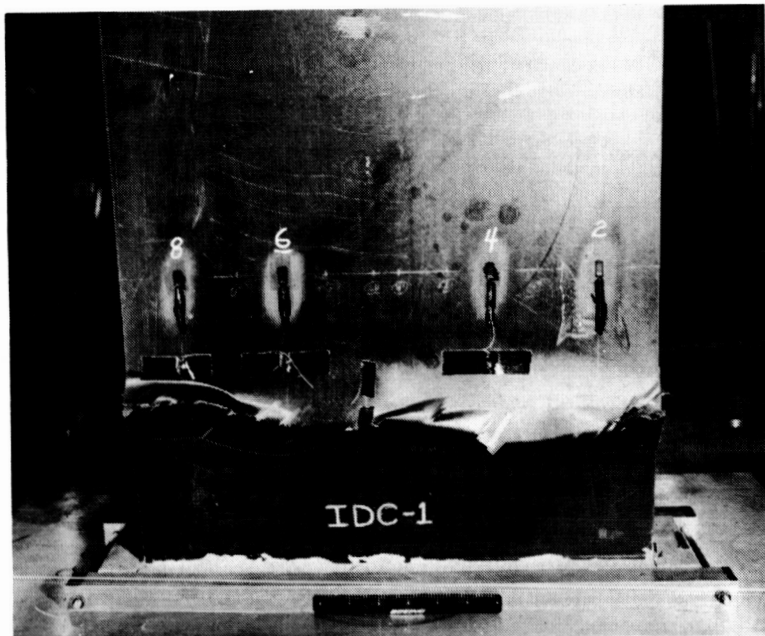
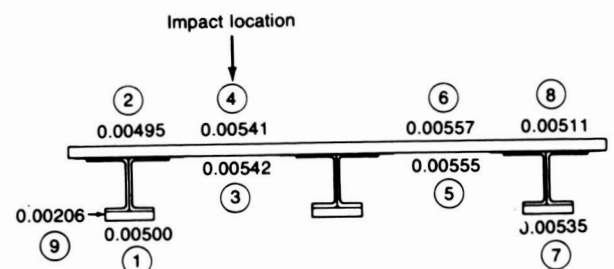
Figure 12. Failed 3I-1 With 600 in.-lb Impact

All three panel concepts were tested in compression after being subjected to impacts that produced nonvisible damage. The first impact was on the skin between stringers. The I-stiffened panel with (30/60/10)% skins (3I-1) was tested to failure after the three impacts noted above. Far-field strains at failure were 0.0054. The J-stiffened panel with (19/62/19)% skins and (40/46/14)% planks (3J-1) was tested to limit load in compression after the first impact. Panels 3J-1 and 3B-1 were impacted a second time directly over the center stringer at 1000 in.-lb by means of a spring-loaded device having a similar impact head and comparable mass to the standard impactor. Craters up to 0.09-in. deep were caused by these skin-side impacts, and delaminations of up to 2-in. diameter (3 in.²) were detected by through-transmission and pulse-echo nondestructive testing.

- Gages ① - ⑧ measured strain parallel to load path
- Gage ⑨ measured strain perpendicular to load path

Panel 3I-1 was impacted by the same blunt-nosed, 0.5-in diameter steel impactor used for the standard tests (ref. 6), but the mass was increased from 10 to 20 lb to get the same extent of damage, because the panel was more flexible than the 5- by 5-in. frame used to support the standard 7- by 10-in. panels. It required three impacts in the same spot, at 300, 450, and 600 in.-lb, to get damage slightly more severe than the damage on the isotropic 7- by 10-in. panel after a single impact at 360 in.-lb. Panel 3I-1 carried 451 kips at 45 ksi after impact at the outer skin surface halfway between stringers. Failure was through the impact site approximately 6 in. from the lower end of the 24-in.-long panel (fig. 12). The skin and all three stringers failed on a plane through the impact site. The strains, shown in figure 12, were recorded in the center of the panel approximately 6 in. from the failure plane just before failure. This represents a substantial improvement in residual strength over the strength indicated by coupon data and shows the importance of testing panels rather than coupons to get wing panel effective working strain levels.

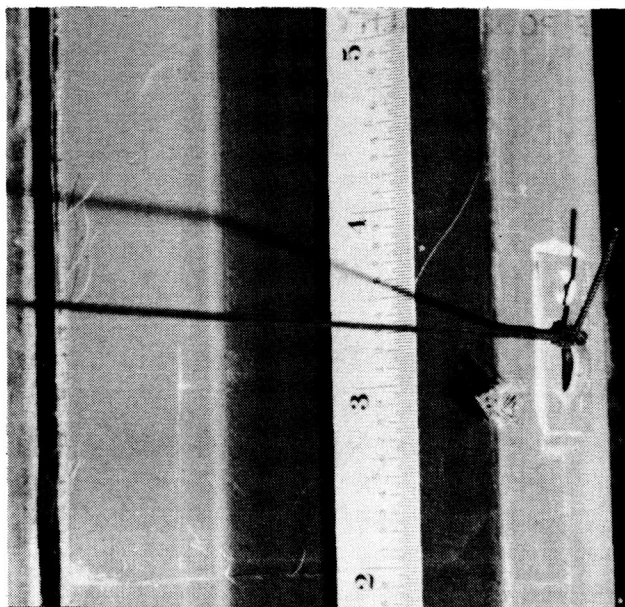
Figure 13. Stringer Impact Damage on Panel 3J-1

The third impact on each panel was applied with a sharp-edged steel bar of approximately 5-lb mass. Impact energy was approximately 300 in.-lb, based on experimental drops of other sharp-edged objects on scrap panels. These impacts were applied to the critical stringer details and represent an exploratory level of damage related to assembly of the wing and maintenance operations carried out inside the wing. Figure 13 shows the stringer damage prior to failure. Panel 3J-1 failed through the 1000-in.-lb. external impact site at 576 kips, at an average panel stress level of 44 ksi. Far-field strains were 0.0055 to 0.0058 on the skins and 0.0059 to 0.0061 on the stringer caps.

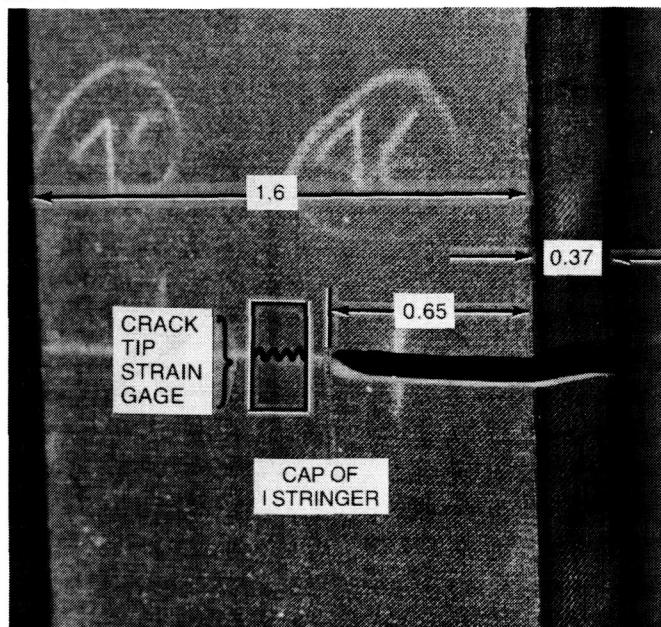
Figure 14. Saw Cut on Panel 3I-3

The most interesting test from a damage-tolerance standpoint was the slow, progressive failure of the I-stiffened panel (3I-3) with a saw-cut center stringer cap (fig. 14). At 170 kips, the gage on the cap near the end of the saw-cut was lost. The last recorded strain was 0.0037. The other gage near the end of the saw-cut increased from 0.0039 at 170 kips to more than 0.017 at 270 kips.

At 270 kips, there was a loud pop accompanied by sudden increases in the side stringer cap strains from 0.003 to 0.0034. The sudden loss of load in the center stringer cap was picked up by the cap gages 2, 4, and 6 in. from the saw cut. At 330 kips, there was a second pop accompanied by a sudden increase from 0.0017 to 0.0033 in skin-side strain immediately above the broken stringer. Finally, at 350 kips, the entire skin laminate buckled away from the stringers, the stringers failed, and the load dropped abruptly to zero.

This progressive failure sequence demonstrated for the first time some inherent damage-tolerance of skin-stringer panels with bonded-on stringers. The load from the failed central stringer was redistributed to the side stringers. The bond lines demonstrated the capacity to absorb the shock loads associated with explosive failure of the stringer element. The shear material in the stringer web proved capable of transferring load between a failed cap and the redistribution load path, the 45-deg-dominated skin. The redistribution load paths remained intact until the far-field strains exceeded 0.004. This indicates that a wing panel having five or more stringers would carry limit load after complete failure of one stringer. This test was repeated on a similar panel with bolts reinforcing the skin/stringer bonds. The failure sequence described above was recorded on high-speed movies. The major redistribution occurred at 230 kips, but ultimate failure load increased 12% to 394 kips.

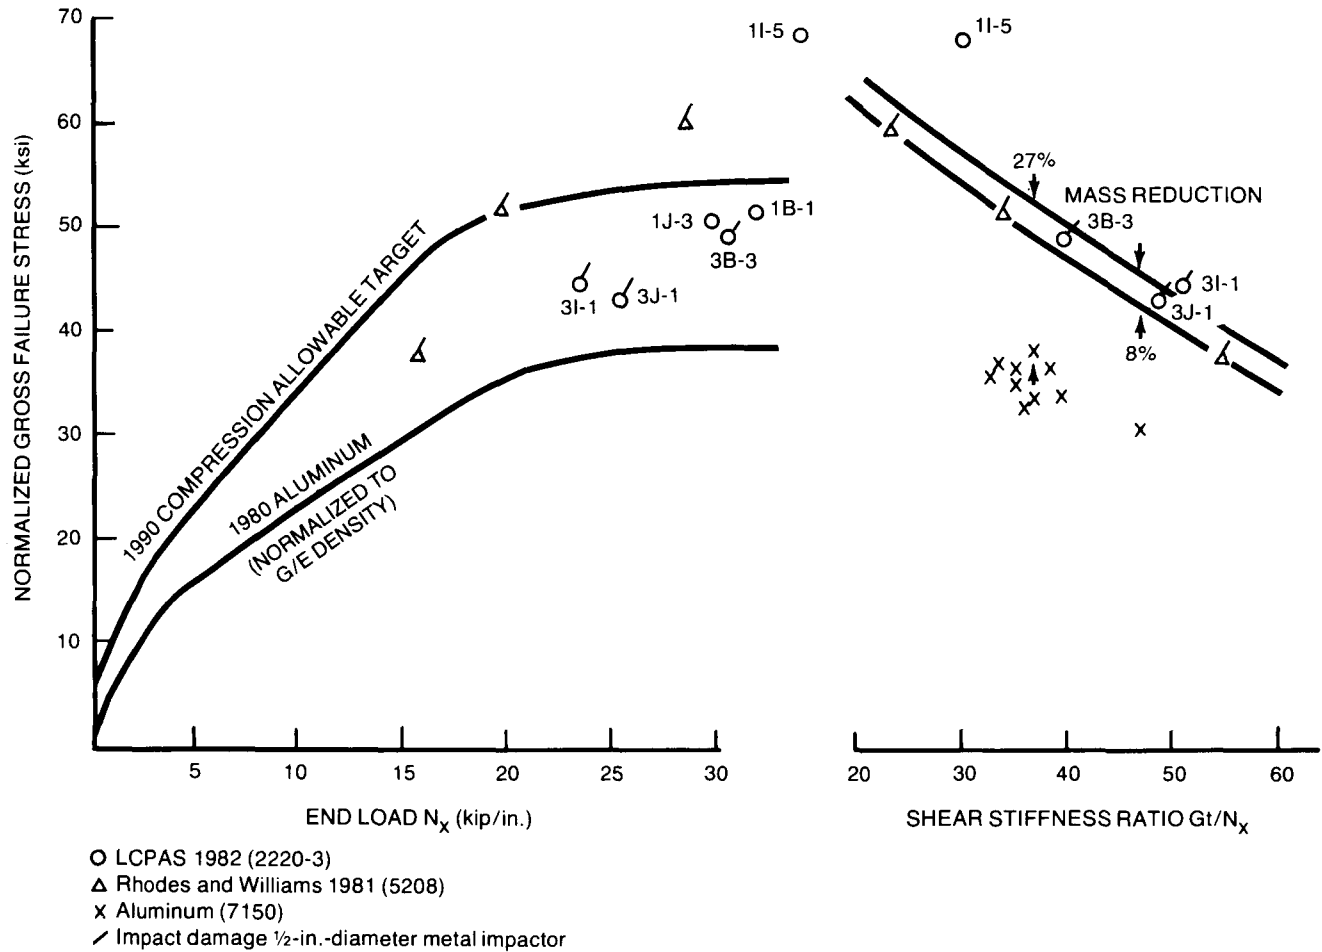
Figure 17. Compression Panel Test Summary

Figure 17 represents a summary of the LCPAS test data on undamaged structural elements and damaged panels.

With nonvisible damage, the LCPAS concepts represent an 8% improvement in compression panel efficiency compared to the best previous industry data obtained by Rhodes and Williams (ref. 4) on panels 1, 3, and 4. The LCPAS panels with nonvisible damage represent a 27% improvement over the best (undamaged) data for aluminum panels.

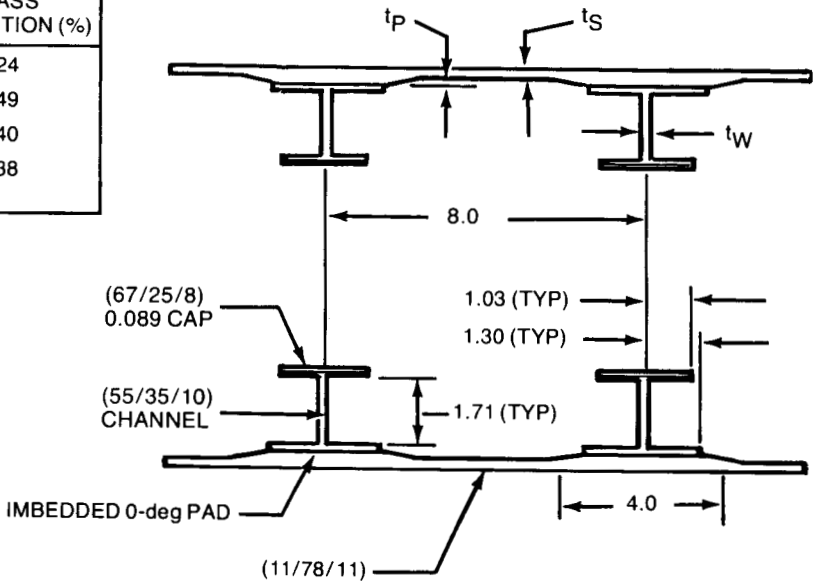
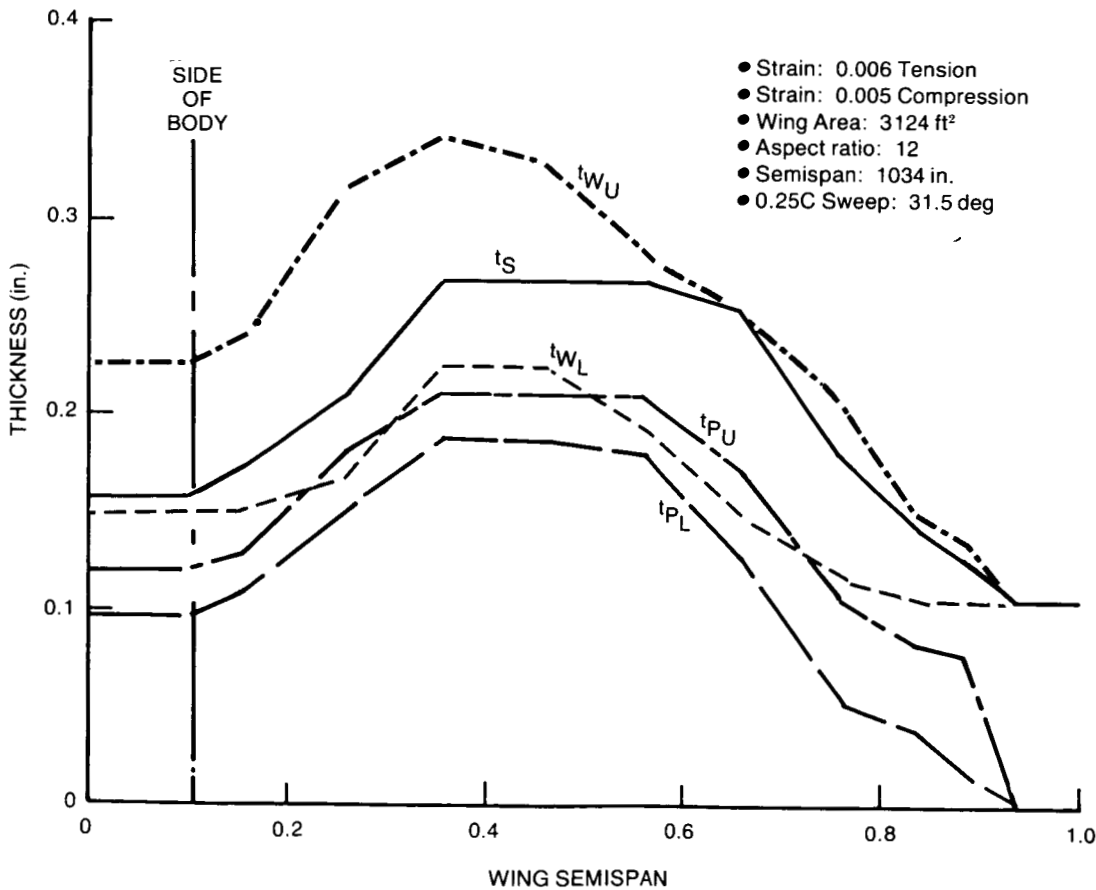
Figure 18. Wing Sizing and Mass Comparison

Figure 18 presents the results of the final wing sizing based on the LCPAS test results. The theoretical mass reduction for wing panels and spars is 38%.

COMPONENT	THEORETICAL MASS REDUCTION (%)
UPPER SURFACE	24
LOWER SURFACE	49
SPARS	40
TOTAL (PANELS + SPARS)	38

Although the blade-stiffened panel can be made to carry 52 ksi as a short column with no local pressure, the demands of combined loads and residual strength favor a discrete stiffener with a substantial bending capability, as provided by the I or J concepts. Because current tooling and assembly techniques favor the I over the J concept, the I concept was selected for the final LCPAS sizing. Because the panel test data, especially for panels 3I-2 and 3B-3, indicate that soft skin configurations are more damage tolerant, the selected skin layup is (11/78/11)%. The wing size shown in figure 18 is based on maximum fiber-direction strains of 0.005 in compression and 0.006 in tension. The soft lower skins with discrete planks were maintained to provide discrete tear straps. Although the almost unidirectional laminate provided good stiffness, strength, and toughness, it would be difficult to repair with mechanical fasteners, so the percentage of 0-deg material was maintained below 67% in all parts of the structure. Although the all-45-deg laminate exhibited damage tolerance, the Poisson ratio associated with this layup might produce fatigue cracks in the metal fittings attached to the wing panels, and the typical rib chords would be highly loaded.
